Assessment of the Ballast Safe Filter Performance in Removing Quagga Mussels Veligers from the Raw Water of Lake Havasu

**Prepared for: Sigma Design Company LLC, Springfield, N.J.
and Maritime Solutions Inc.**

**Renata Claudi MSc, Tom Prescott MSc, PEng., Carolina
Taraborelli MSc**

Date: February 24, 2008

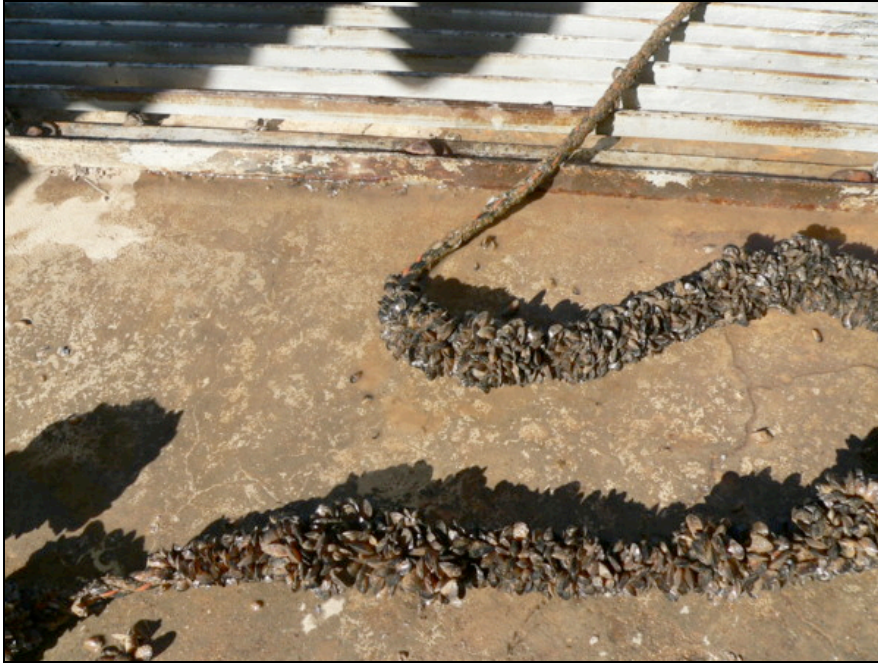
• Figure 2: Mussel densities are high at Parker. Photo shows a 1/2" rope infested after 1 season

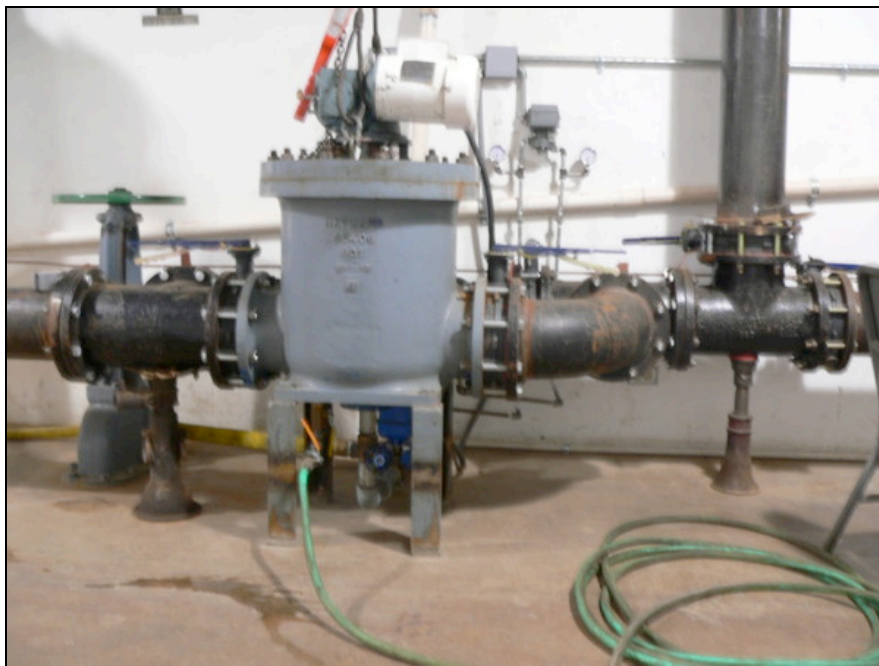
• Figure 3: Existing Hayward strainer upstream of BallastSafe Filter

The screen openings in the Hayward strainer are approximately 3/16 wide. The strainer will allow mussel veligers to pass and enter into the piping downstream of the strainer. The strainer self-cleaning system incorporates a wiper mechanism that

scrapes across the screen surface during backwash. The wiper appears to crush mussel shells that are lodged in the screen openings and some shell debris is therefore passing through the strainer. In addition, small live adult quagga mussels are able to pass through the mesh openings in the strainer. The source of the shells and live adults is the 8" piping and header, including the portion embedded in the dam. These areas are heavily fouled by settled mussels.

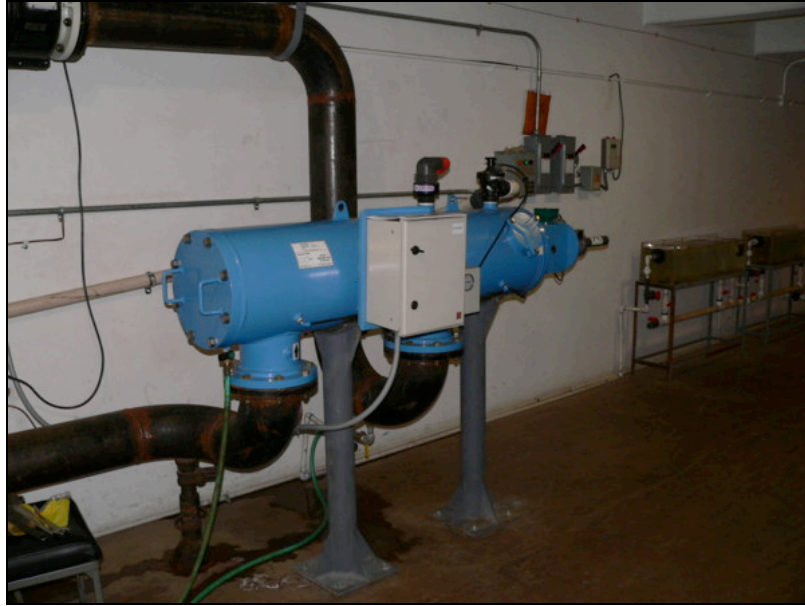
• Figure 4: Ballast Safe Filter installed at Parker

The Ballast Safe filter body is a cylindrical housing with a bolted cap at both ends. There are three inner chambers. There is one chamber for a strainer to pre-filter the

water, the next chamber is for the filtration and the third chamber is for the backwash. The chambers are created by two annular metal rings inside the housing. The filter cartridge is also a cylindrical assembly with the strainer basket and the filter attached in line. The diameter of the filter cartridge is slightly smaller than the inner diameter of the two annular rings so that when the cartridge is inserted into the housing the three chambers are formed by rubber seals between the filter cartridge and the rings.

There are three flow ports. There is an inlet port at the pre-filter strainer chamber, an outlet port at the filter chamber and a smaller waste discharge port at the backwash chamber.

The online backwash is achieved by small nozzles that float on the inside surface of the filter mesh. The nozzles are connected to a discharge manifold by radial arms. The arms and discharge manifold rotate and translate during a backwash to vacuum the debris from the surface of the mesh. The backwash manifold is driven by an electric motor and worm drive.

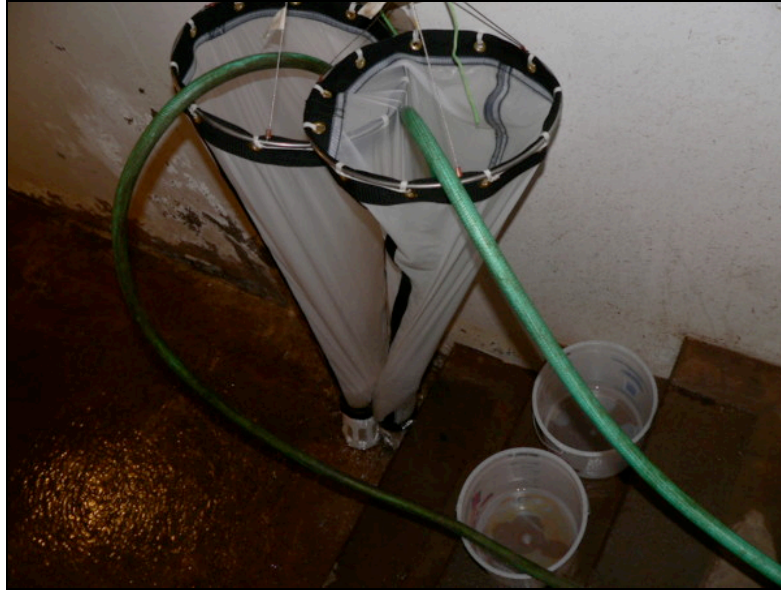
• Figure 5 : Test sample 20 micron collection nets

The test began on February 2nd, 2009. Dedicated hoses were attached to the sampling ports provided just before and just after the filter. The valves on the sampling ports were opened and the volume of flow from each port was determined by running the water into graduated buckets. The valves on the sampling ports were adjusted until both ports were passing the same volume of flow. The time required to collect predetermined sample volume was calculated based on the volume of flow. The sample from each port was then collected by passing the water from each hose through dedicated 20 micron, brand new plankton nets. Both samples were collected at the same time.

Once the required collection time was achieved, the hoses were removed from the nets and the nets were taken to the sample collection table. The sample collection buckets at the bottom of the nets were removed and the sample from each bucket was transferred into a separate, labeled sample collection bottle. The label contained the date of collection, the micron size of the filter screen being used, the time of the collection and if the sample was collected before or after the filter. Extreme care was taken to prevent any cross contamination from non-filtered to filtered samples by using dedicated equipment for each sampling stream.

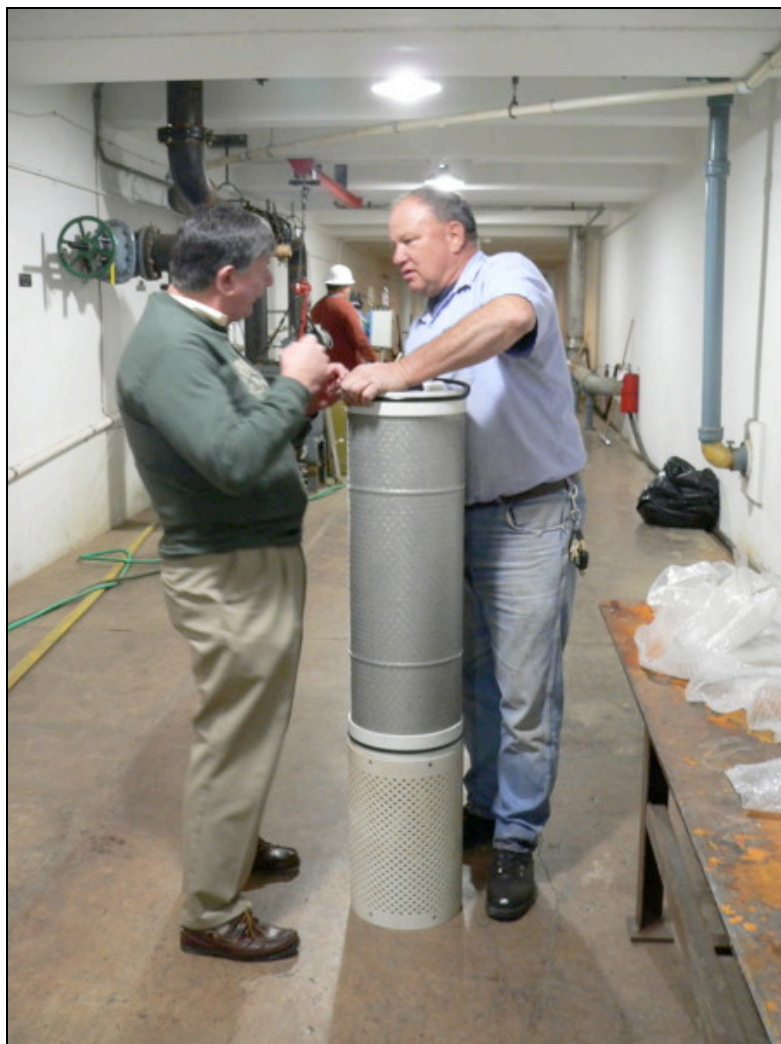
• Figure 6: Filter cartridge being prepared for change-out

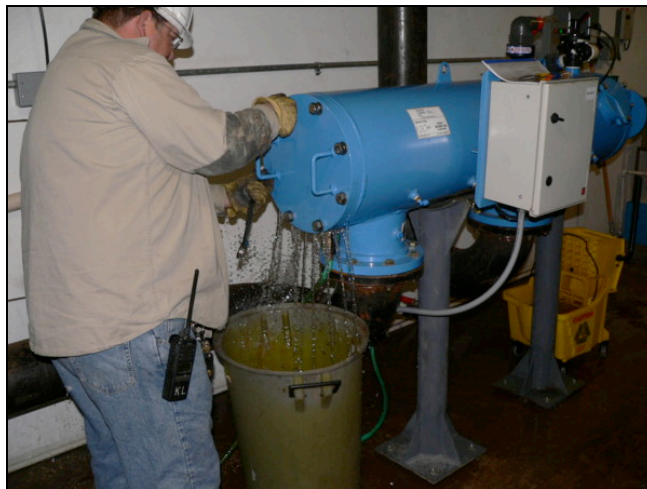
• Figure 7: Opening the filter housing to change the filter cartridge

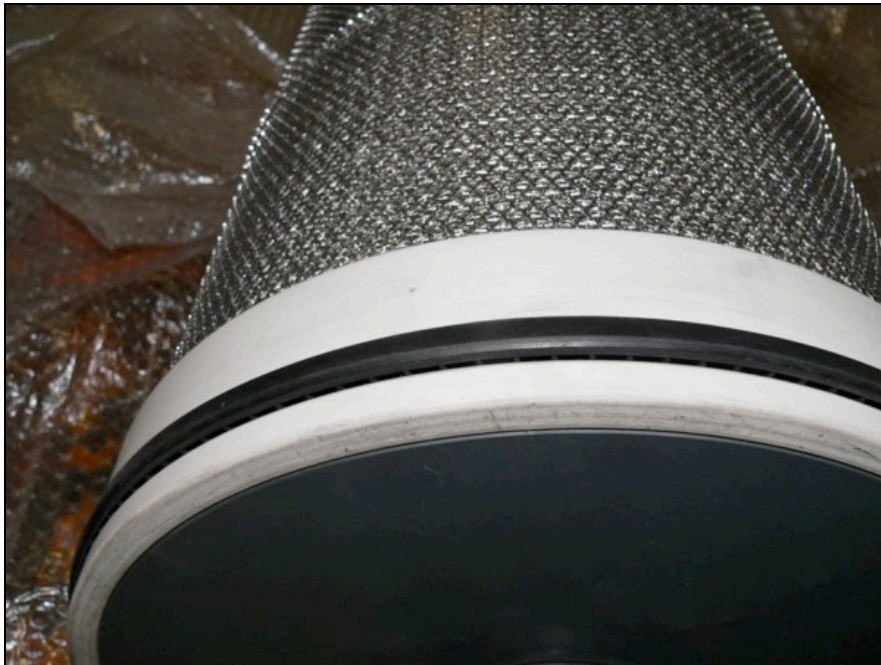
• Figure 8: Seal at backwash end of filter as received

The filter was taken out of service and the screen was removed. Careful examination of the filter screen revealed that the V shaped seal which separates the filtered water from the backwash chamber appeared to have been installed backwards. After

consultation with the filter vendor, the seals on both screens (the 80 micron and the 40 micron) were reversed. The 80 micron screen was installed and the evaluation process was restarted. Two samples of 400L were collected. Subsequently the sample size was increased to 1,000L.

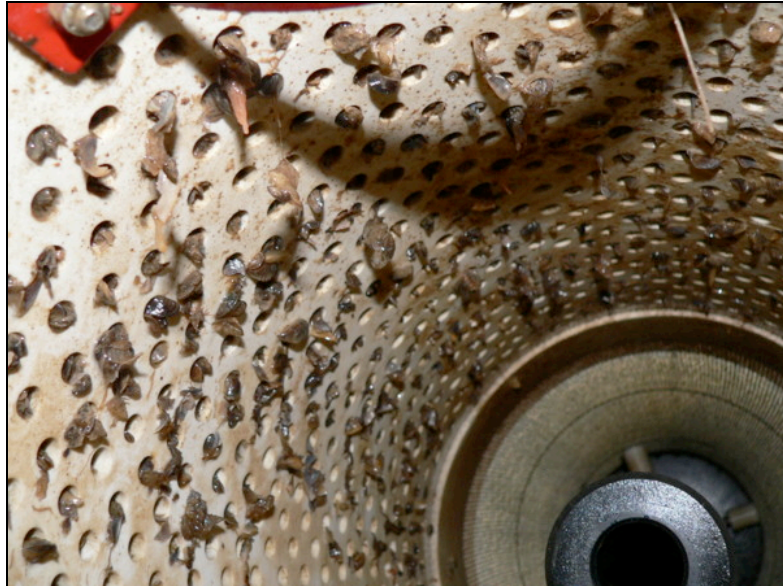
- Figure 10: Inside of pre-strainer showing damaged mussels from Hayward strainer entering Ballast Safe filter.

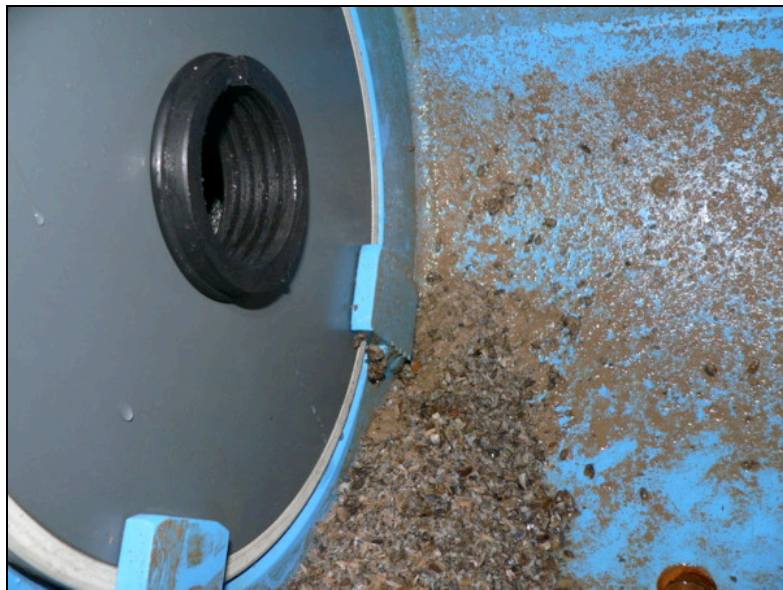
- Figure 11: Inside of backwash chamber showing typical debris removed from water stream

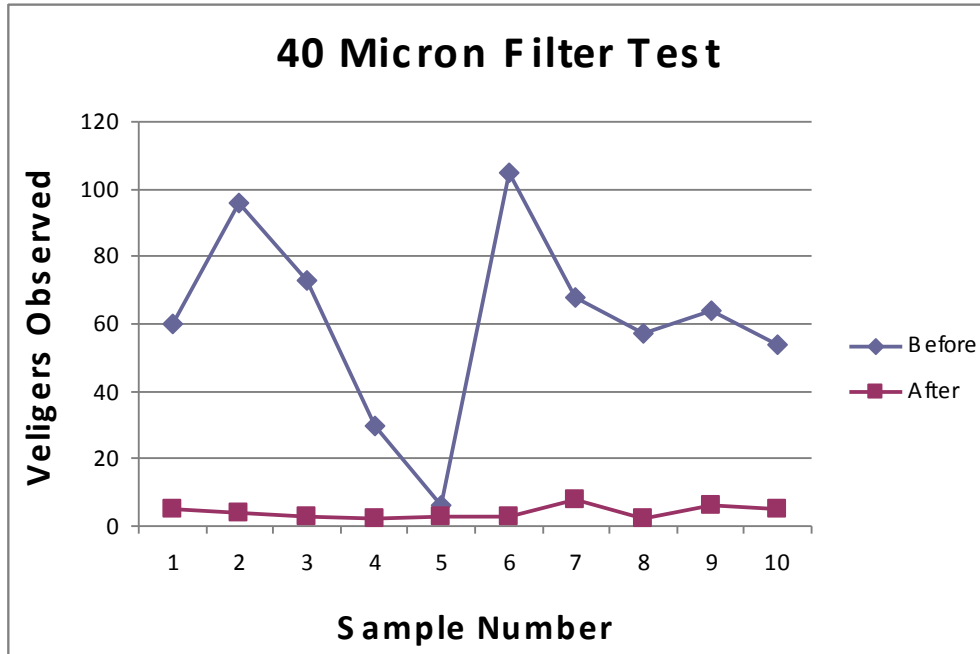
Below are graphs of the results obtained with the 40 micron filter mesh. The raw data is contained in a table in Appendix 1. The following graph shows the veligers removal across all veliger size ranges. In all samples, there was a significant difference between the numbers of veligers coming into the filter and numbers of veligers exiting.
